# PERBADANAN PENGURUSAN PALM SPRING @ DAMANSARA

Ref : PSMC/Inter-Floor Leakage/2024/028

We have recently received a complaint from the occupant of Unit B-0915 regarding an inter-floor leak affecting their unit. Following this report, our maintenance team conducted an inspections at Unit B-0915 on 03/02/2024.

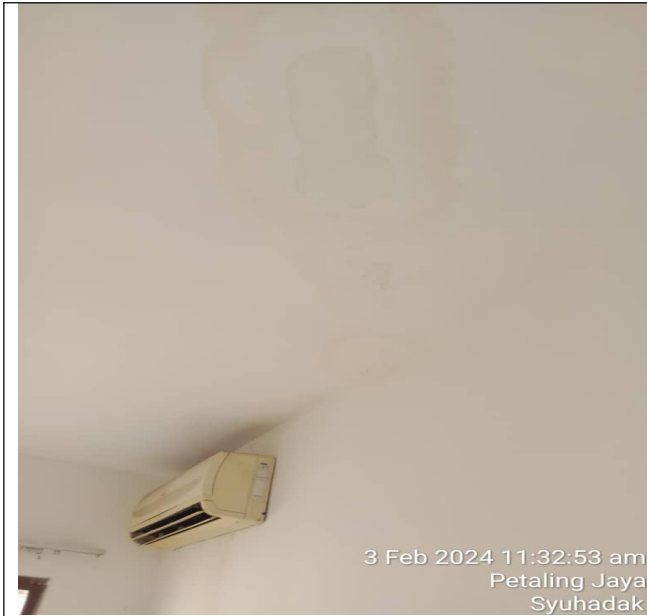
This leakage has caused damages to the ceiling located at **Room 1 and Master Bedroom Toilet Area**. Our maintenance personnel have verified the dampness caused by the leakage, and we highly suspect that the issue is caused by the leaked of your pipe from master bedroom toilet.

**Picture 1:** The damages ceiling and water mark located at room 1 area.

It is imperative that you take immediate action to address this matter by assigning your contractor to repair the leak as soon as possible. Failure to do so could result in further damage to the unit below.

To prevent further inconvenience to your fellow neighbors, we would appreciate it if you could communicate with them and appoint a professional/contractor to resolve this matter **WITHIN 14 days** to prevent any further damages.

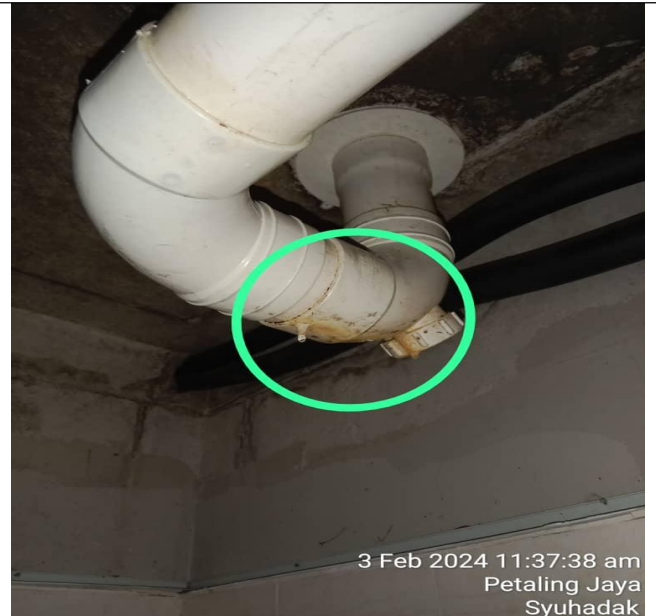
**Picture 2:** The water mark suspect due to the pipe leaked at master bedroom toilet.

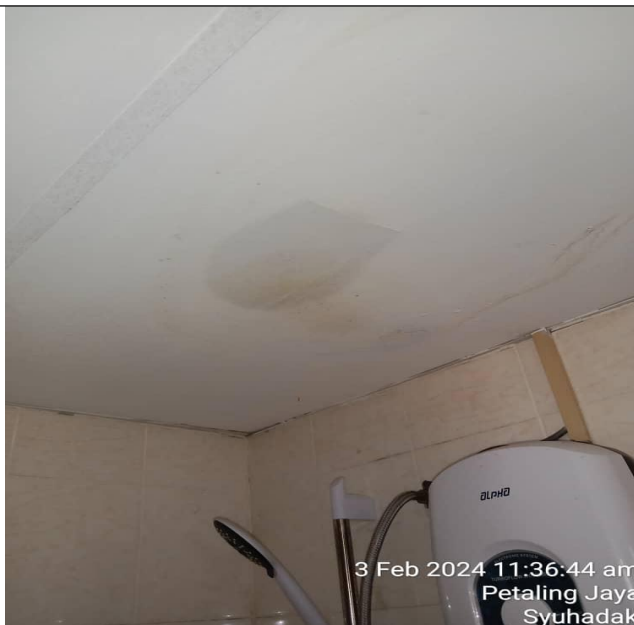
**Picture 3:** The ceiling and water mark on the wall located at master bedroom toilet area.

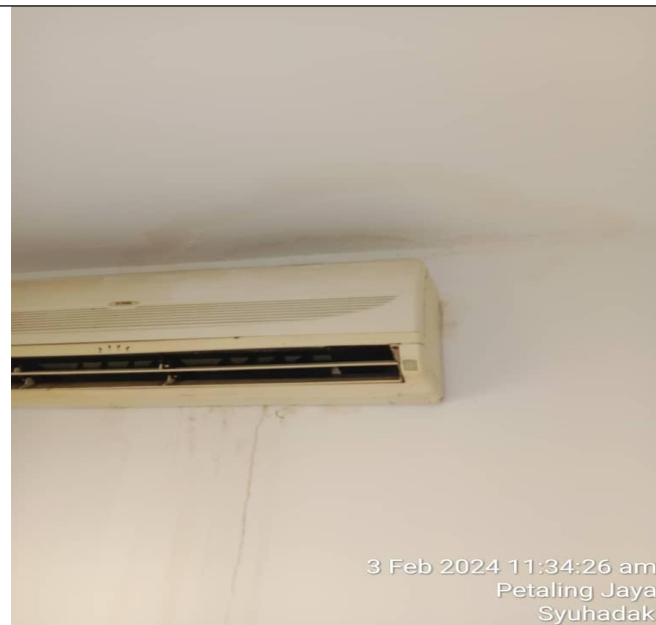
**Picture 4:** The damages ceiling and water mark located at room 1 area.
